We would like to thank you for requesting our assistance to identify the specific soil properties on your company's property on Wells Run Road (6B), near the junction of Garland Creek Road and Wells Run Road, Crown City, in Gallia County, Ohio.

Soil and Site Evaluation Discussion

Sketch Map for Countrytyme - #6B -Wells Run Road part parcel # 01100152100

Sketch Map for Countrytyme - #6A -Wells Run Road part parcel # 01100152100

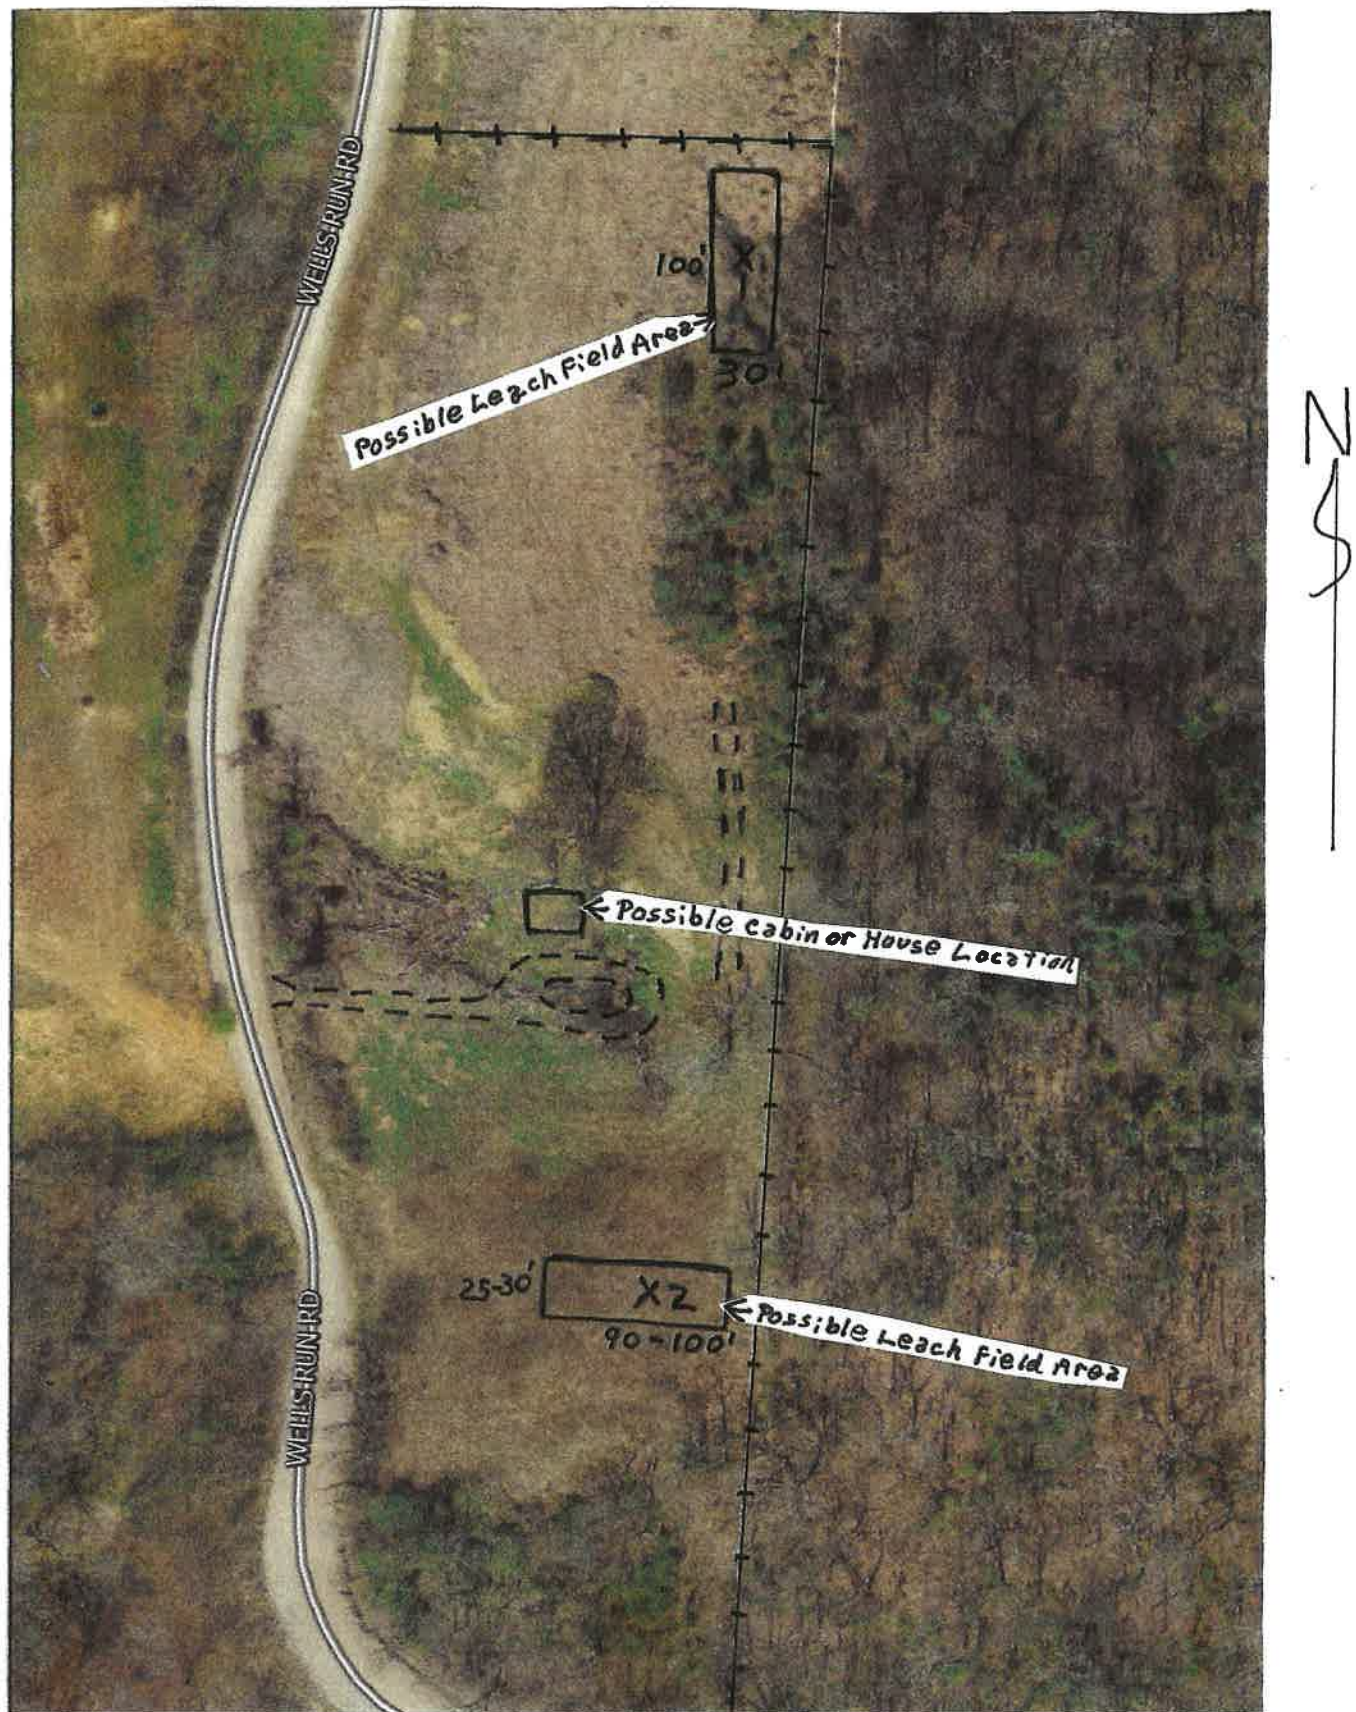
The soils in the proposed leach field areas will be similar to the soil site descriptions. The #1 soil is more loamy and has sandier soils in the soil profile, but you will find some clay at a deeper depth. We also noted a little water seep south of the proposed leach field area. If the system is installed at this location and you have excess water around the leach field, you can assume it's coming from upslope, so install a french drain upslope of the leach field and the wetness should disappear. The #2 soil has more clay in the soil profile, so this area will require a larger leach area and maybe some loamy fill if you elevated the infiltrators or chamber because of the shallower seasonal water table at a 21 inch depth. The Gallia County Health Department will work with you and your installer on what is needed for the STS. I can see either of the proposed leach field areas as the primary leach area. The #1 soil leach area is further away from the possible house or cabin location and will require more leach line. The #2 location will require elevating the chambers or leach lines and adding some loamy fill, and more leach lines. When the sewage treatment system is installed, either of these locations should work very good for and STS leach field area.

We have shown the location of the proposed STS leach field areas on the sketch map. We have marked the proposed leach field area corners with pink wire flags. The soil description sites are marked with an orange flag in the approximate center of the leach area with the number of the soil description. The approximate dominion, of the proposed leach field areas are similar on the same contour of the slope or 100+ feet long around the slope and 30+ feet wide. We gave a house/cabin site location (example that may change with new owner) on the sketch map to give you a possible reference point, for this report. These soils will be very similar to the soil site description in the proposed leach field area.

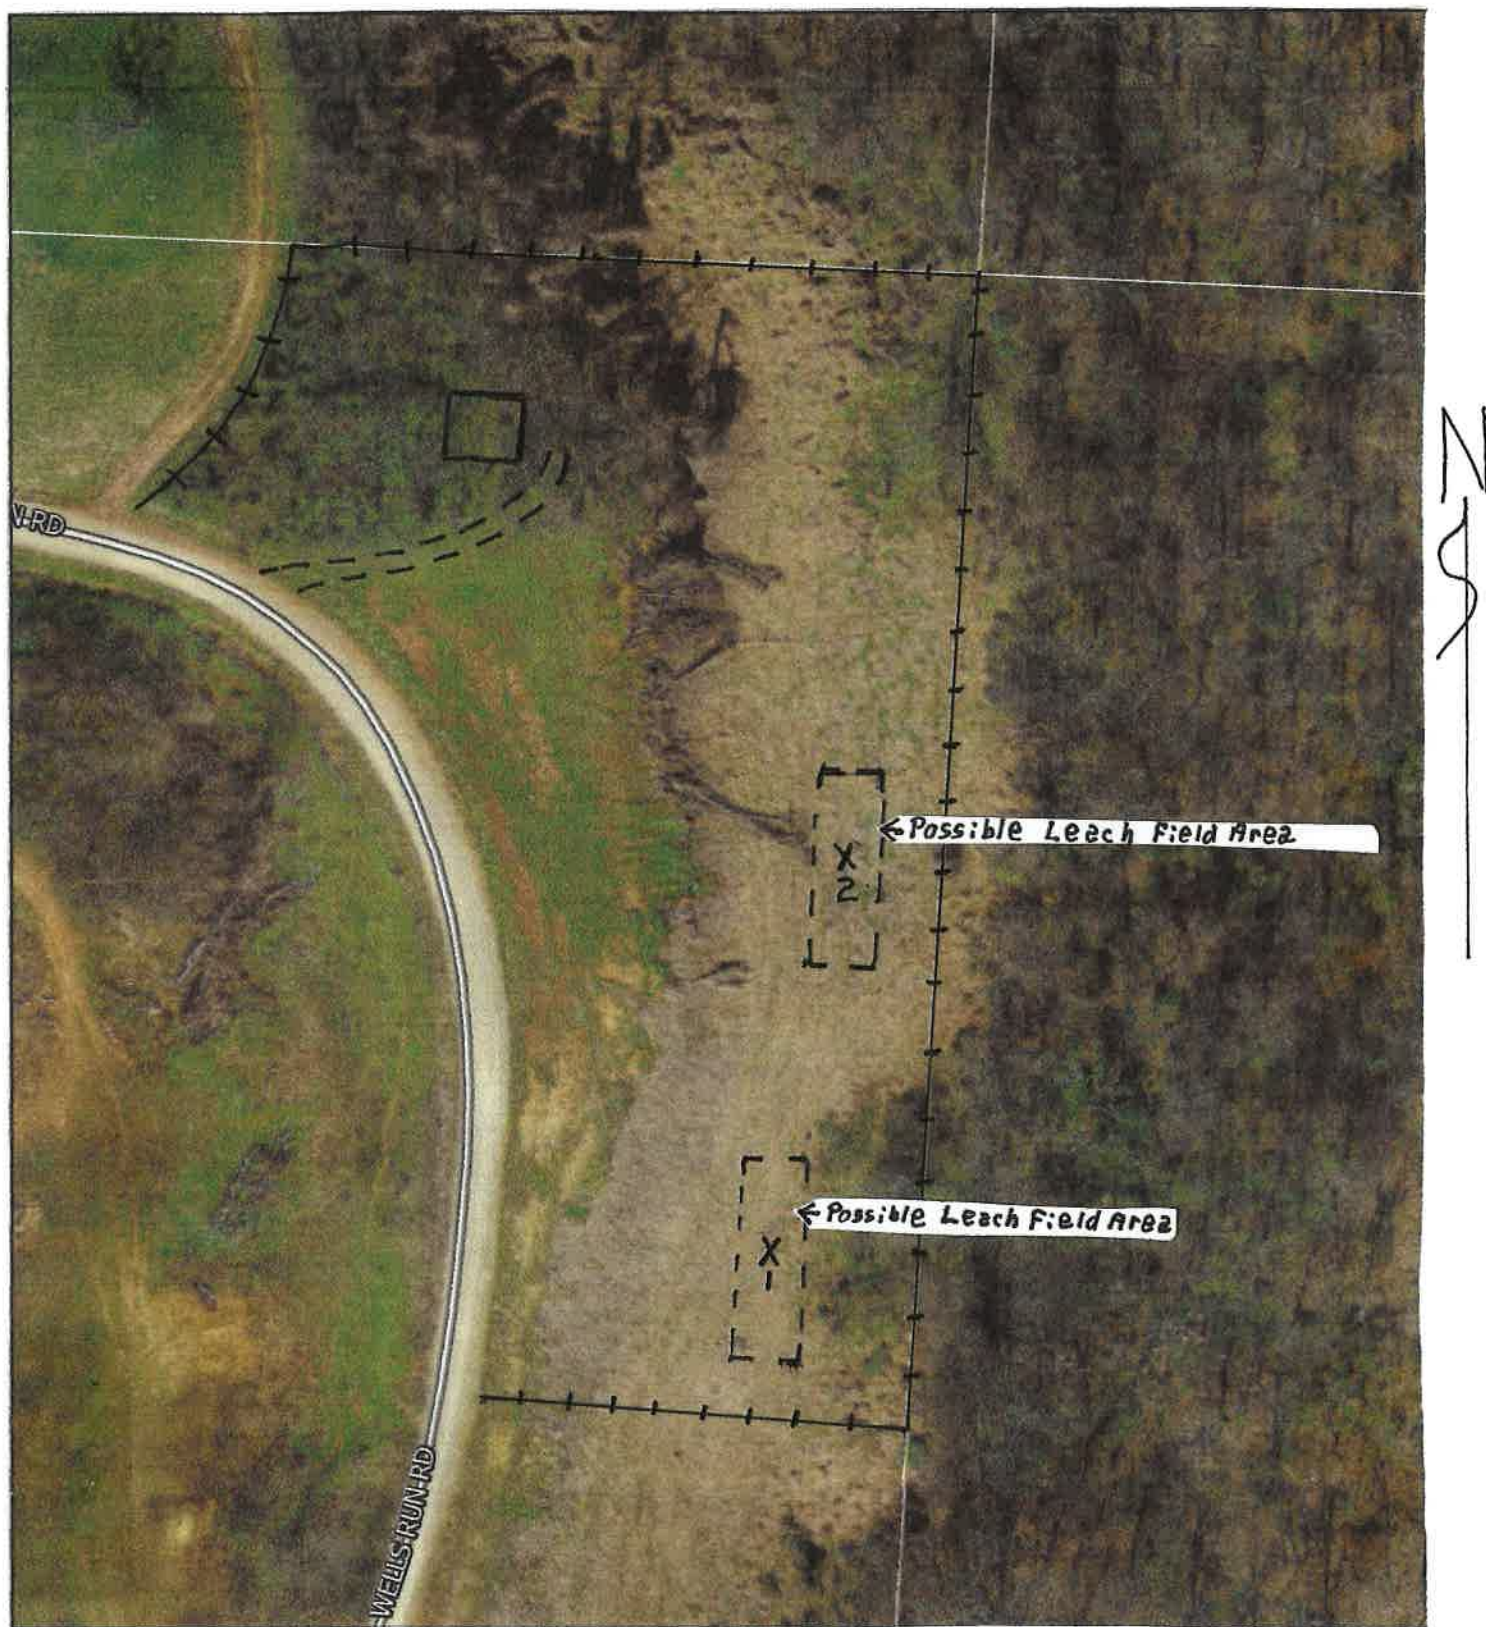
The soils in each of the proposed leach field areas are similar to the soil site description, within the leach area. If you notice with depth in each of the proposed leach field areas, the soils do increase in clay, in the very lower part of the soil profile. The sandy/loam sediments appear to be colluvial sediments that over lay, the more residual portion of the soil profile.

We have shown the location of the proposed STS leach field areas on the sketch map. We have marked the proposed leach field area corners with pink wire flags in some locations and others just an orange flag in the proposed center of the leach area with the number of the description. The approximate dominion, of the proposed leach field areas are similar on the same contour of the slope or 100+ feet long around the slope and 30+ feet wide. The soil site descriptions were taken in the approximate center of the leach area. We gave a house/cabin site location (example that may change with new owner) on the sketch map to give you a possible reference point, for this report. These soils will be very similar to the soil site description in the proposed leach field area.
