We would like to thank you for requesting our assistance to identify the specific soil properties on your property (**Track # 4, Pleasant Valley Woods - Union Road**), Chillicothe, in Ross County, Ohio.

Soil and Site Evaluation Discussion

Sketch Map for Countrytyme Property

Pleasant Valley Woods-Track #4 Ross County

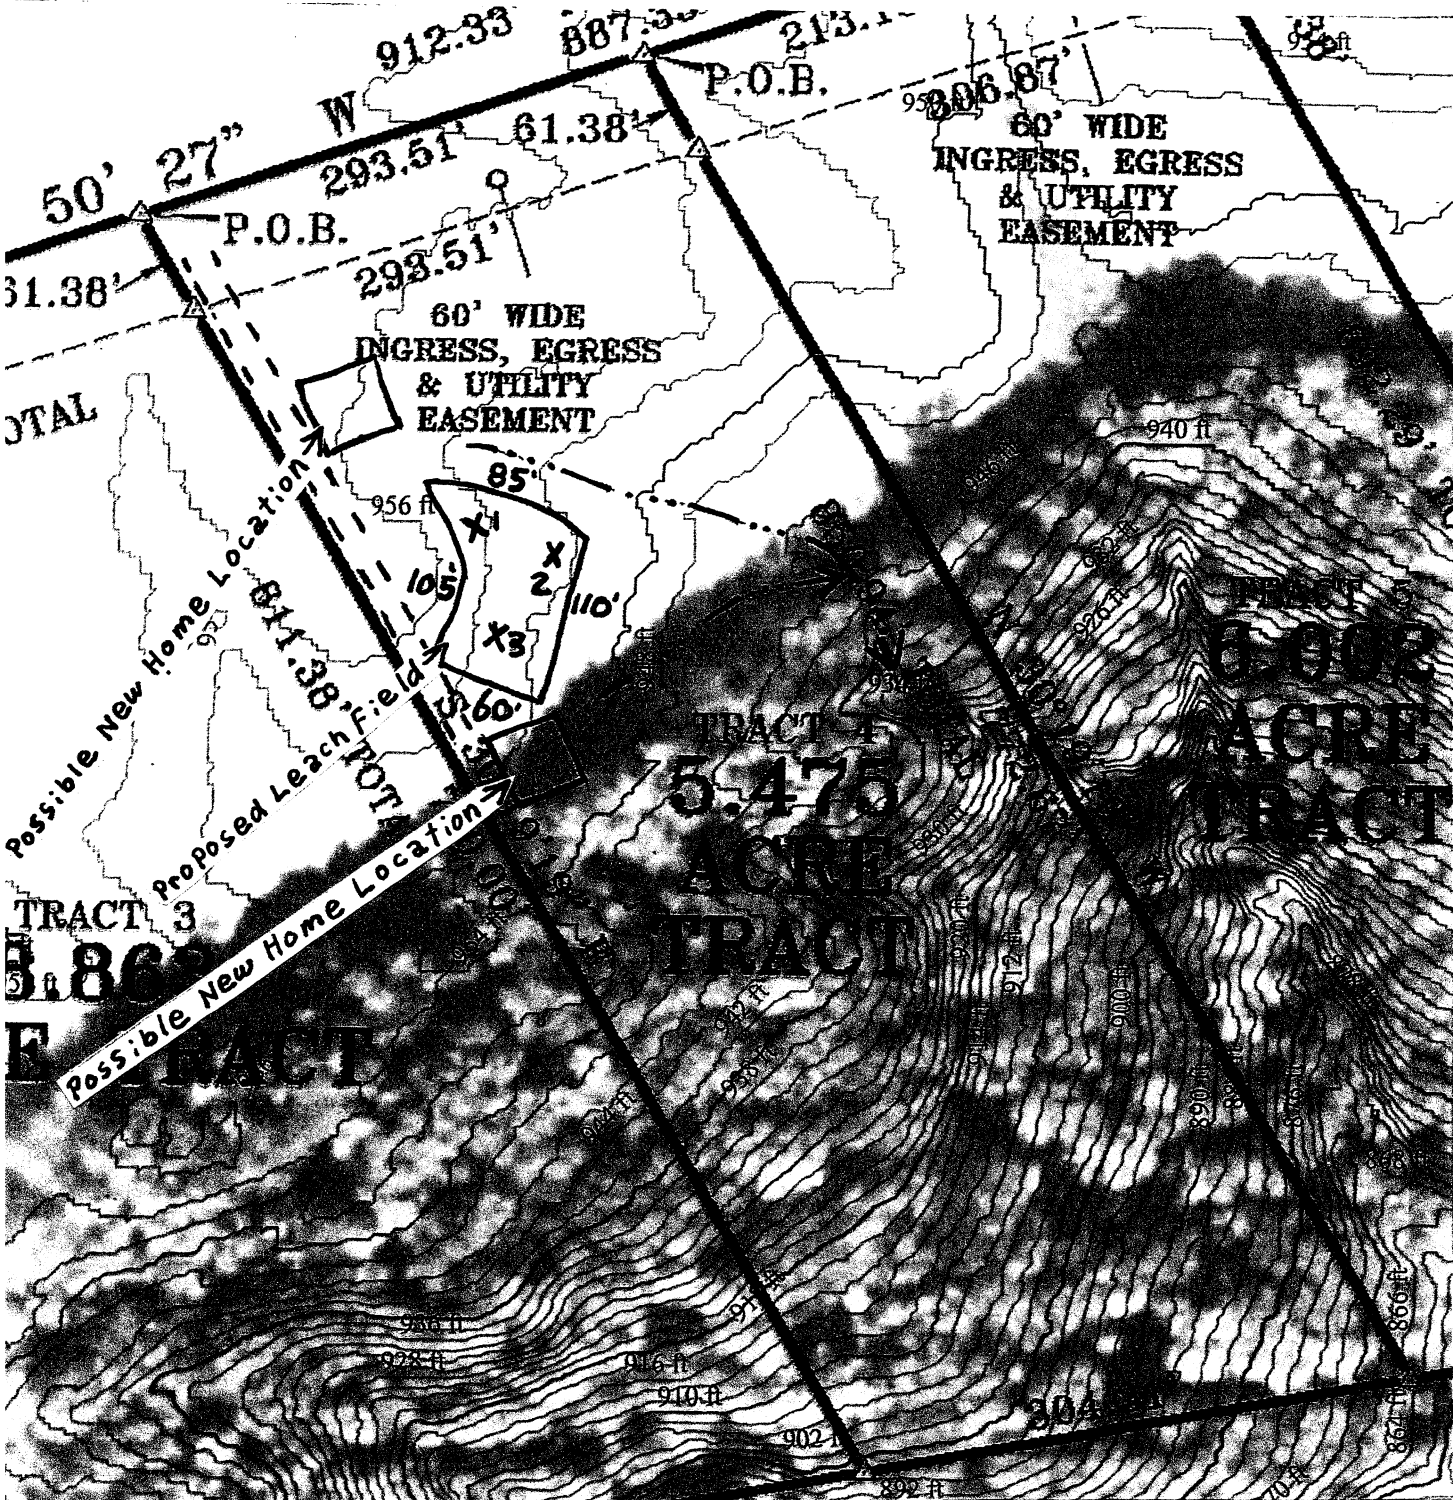
We have shown the location of the proposed STS leach field on the sketch map. We have marked the proposed filter field area with pink wire flags along the boundary and/or on the boundary corners. The soil description sites are marked with orange wire flags and the number of the description is marked on the flag. The approximate dominion, of the proposed filter field area, is marked on the sketch map. The proposed leach field area is just an indication of the area that can be used, the installer or the health department will determine where the filter lines will be located. The filter field lines would need to be located level on the contour around the slope. These soil descriptions were taken at random to show the soil properties at different areas within the proposed filter field area and the sketch map is not to scale. The proposed leach field can be extended around the slope, if needed. We gave a house site location (example that may change with new owner) on the sketch map to give you a possible reference point, for this report.
