We would like to thank you for requesting our assistance to identify the specific soil properties on your property (**Track #1 – Phase 4**), Chillicothe, in Ross County, Ohio.

Soil and Site Evaluation Discussion

Sketch Map for Countrytyme Property

Phase 4, Track #1 - Ross County

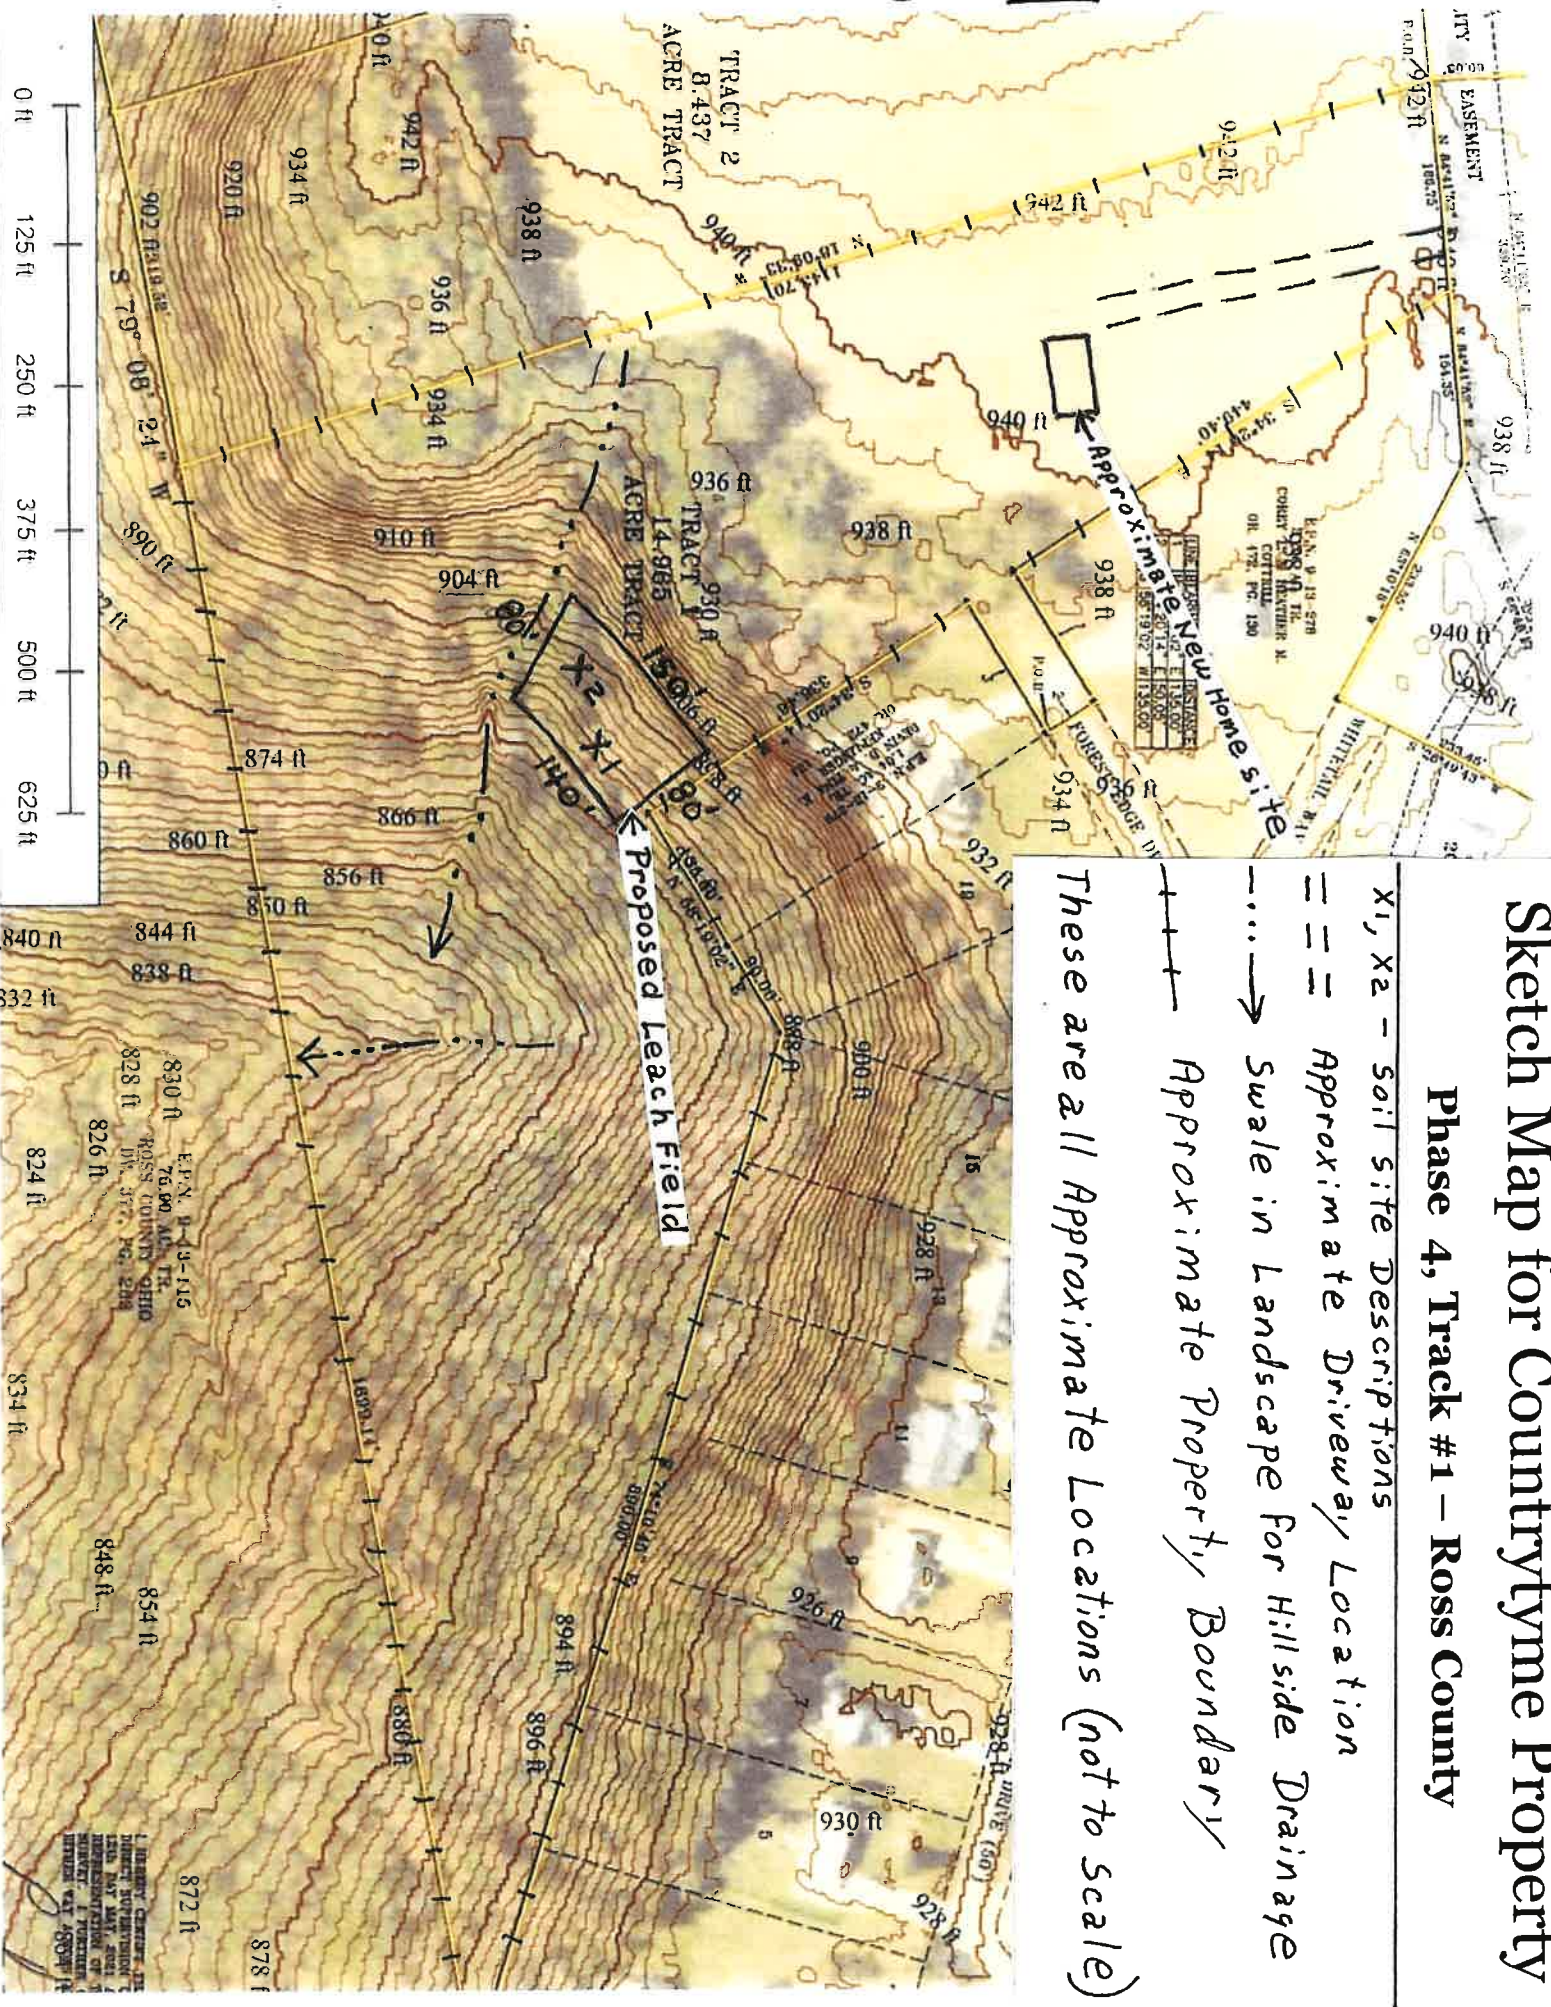
We have shown the location of the proposed STS leach field on the sketch map. We have located a possible new home location, however the new home can be located at any location upslope of the proposed leach field area to get gravity flow of the waste water to the leach field. We have marked the proposed leach field area with pink wire flags on the boundary corners and pink ribbon around the leach field (this proposed leach field boundary maybe marked somewhat irregular, because of the thick vegetation). The soil site description sites are marked with orange wire flags and the number of the description is marked on the flag. The approximate dominion, of the proposed leach field area, is marked on the sketch map. The proposed leach field area is just an indication of the area that can be used, the installer or the health department will determine where the filter lines will be located. The leach lines will need to be located level on the contour around the slope. These soil descriptions were taken at random to show the soil properties at different areas within the proposed leach field area and the sketch map is not to scale. We gave a house site location (example that may change with new owner) on the sketch map to give you a possible reference point, for this report.
