November 19, 2021

We would like to thank you for requesting our assistance to identify the specific soil properties on your property (Track #5-Phase 4), Chillicothe, in Ross County, Ohio.

Soil and Site Evaluation Discussion

Site and Soil Evaluation for Sewage Treatment and Dispersal

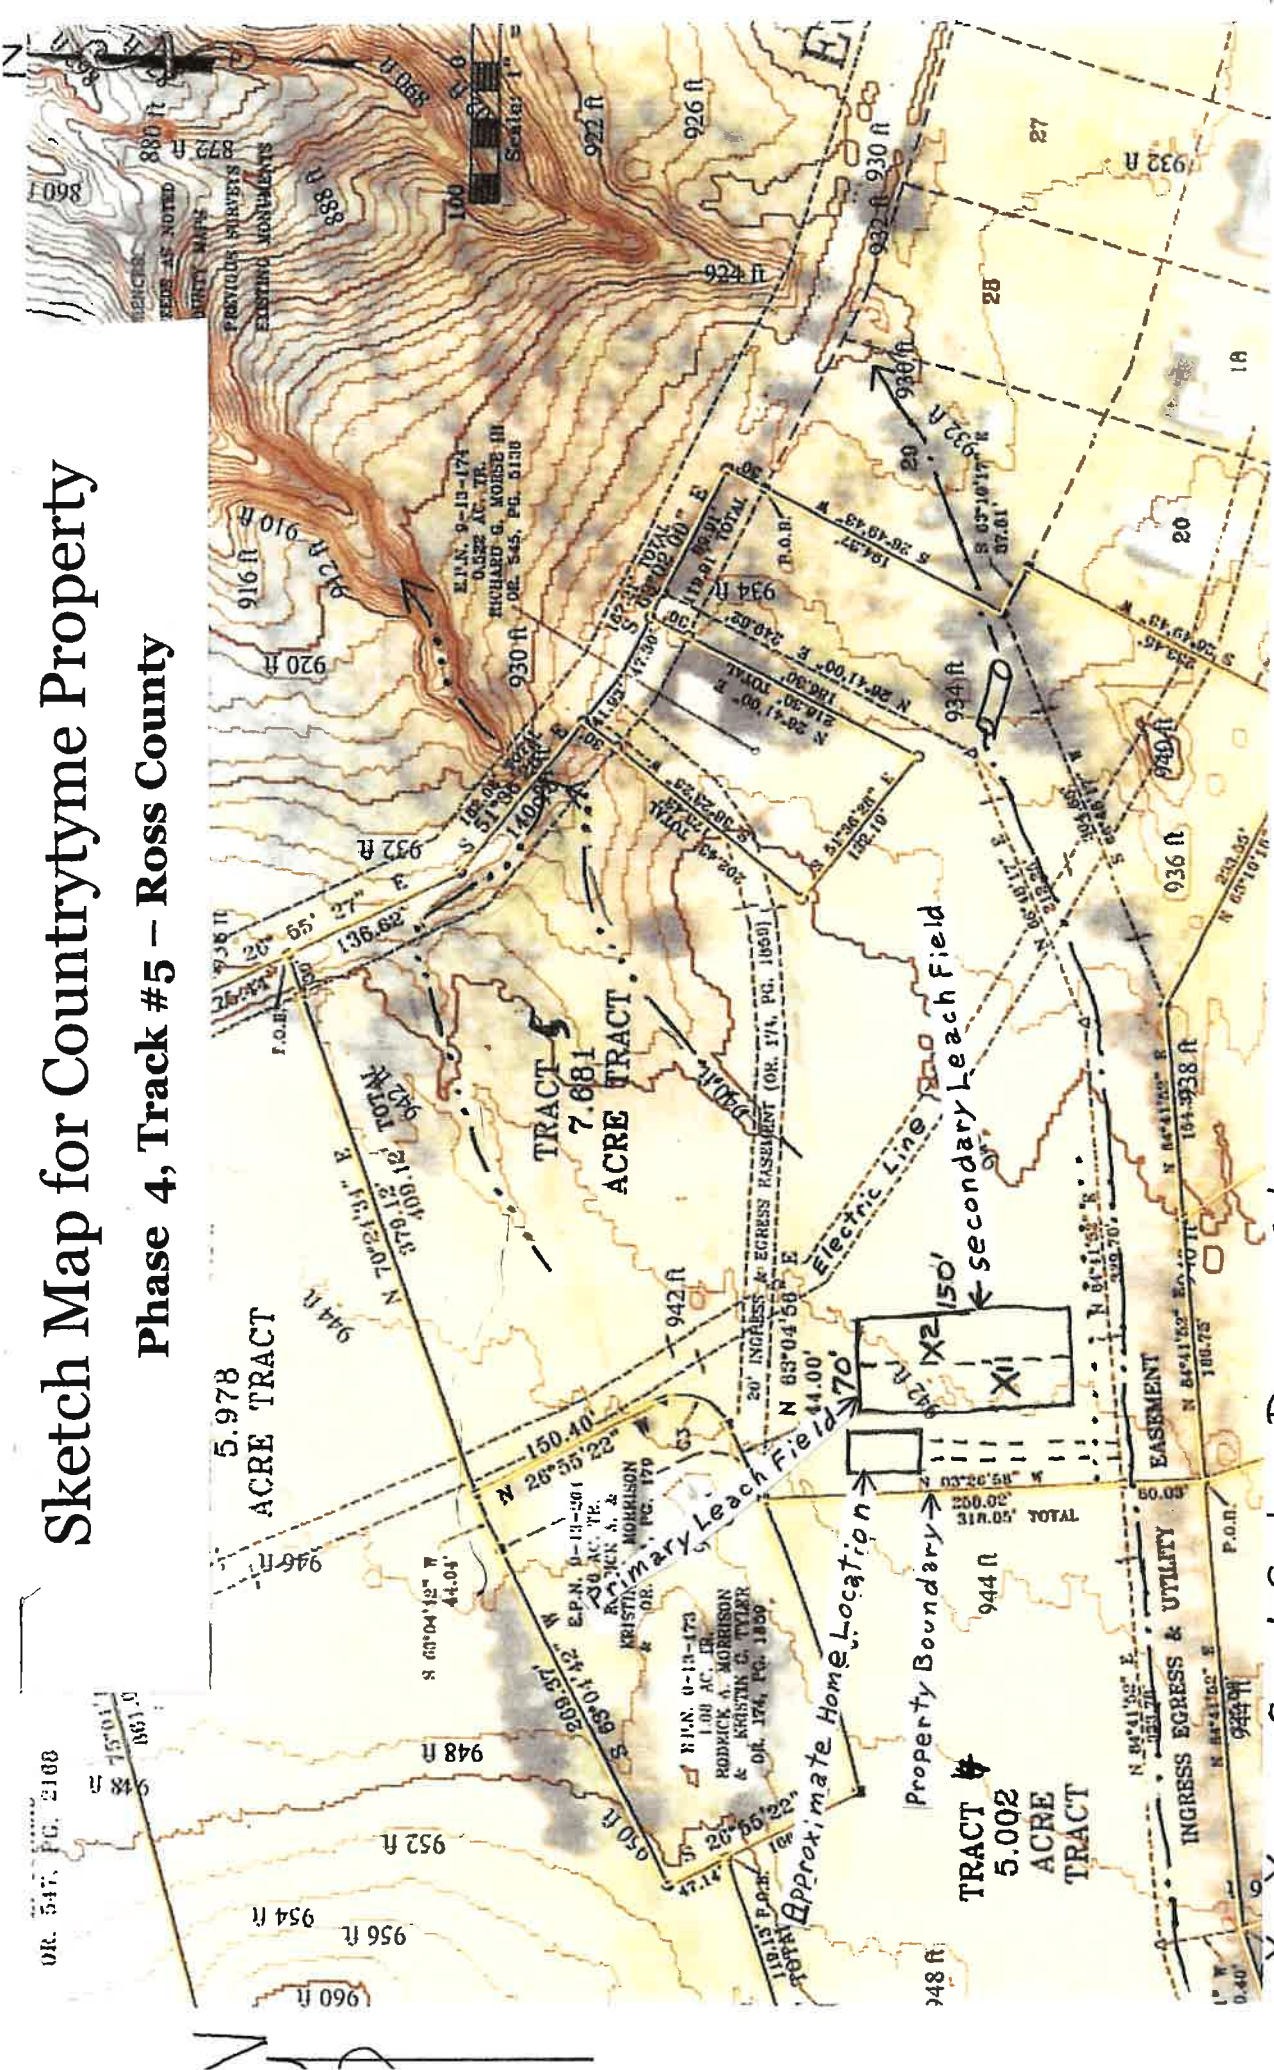
Sketch Map for Countrytyme Property

We have shown the location of the proposed STS leach field on the sketch map. We have located a possible new home location. We have marked the proposed leach field area with pink wire flags along the boundary and on the boundary corners. The soil description sites are marked with orange wire flags and the number of the description is marked on the flag. The approximate dominion, of the proposed leach field area, is marked on the sketch map. The proposed leach field area is just an indication of the area that can be used, the installer or the health department will determine where the filter lines will be located. The leach lines will need to be located level on the contour around the slope. These soil descriptions were taken at random to show the soil properties at different areas within the proposed leach field area and the sketch map is not to scale. We gave a house site location (example that may change with new owner) on the sketch map to give you a possible reference point, for this report.

X1, X2 - Soil Site Descriptions

- → Swale in Landscape for Surface water Drainage
- .-.-.-.- → Drainage Ditch along Ingress-Egress Entrance Road ~~or~~ Culvert
- ==== → Approximate New Home Driveway
- Approximate Public Water line

These are all Approximate Locations (not to scale)
