We would like to thank you for requesting our assistance to identify the specific soil properties on your property (**Track # 7, Pleasant Valley Woods - Union Road**), Chillicothe, in Ross County, Ohio.

Soil and Site Evaluation Discussion

Sketch Map for Countrytyme Property

Pleasant Valley Woods-Track #7 Ross County

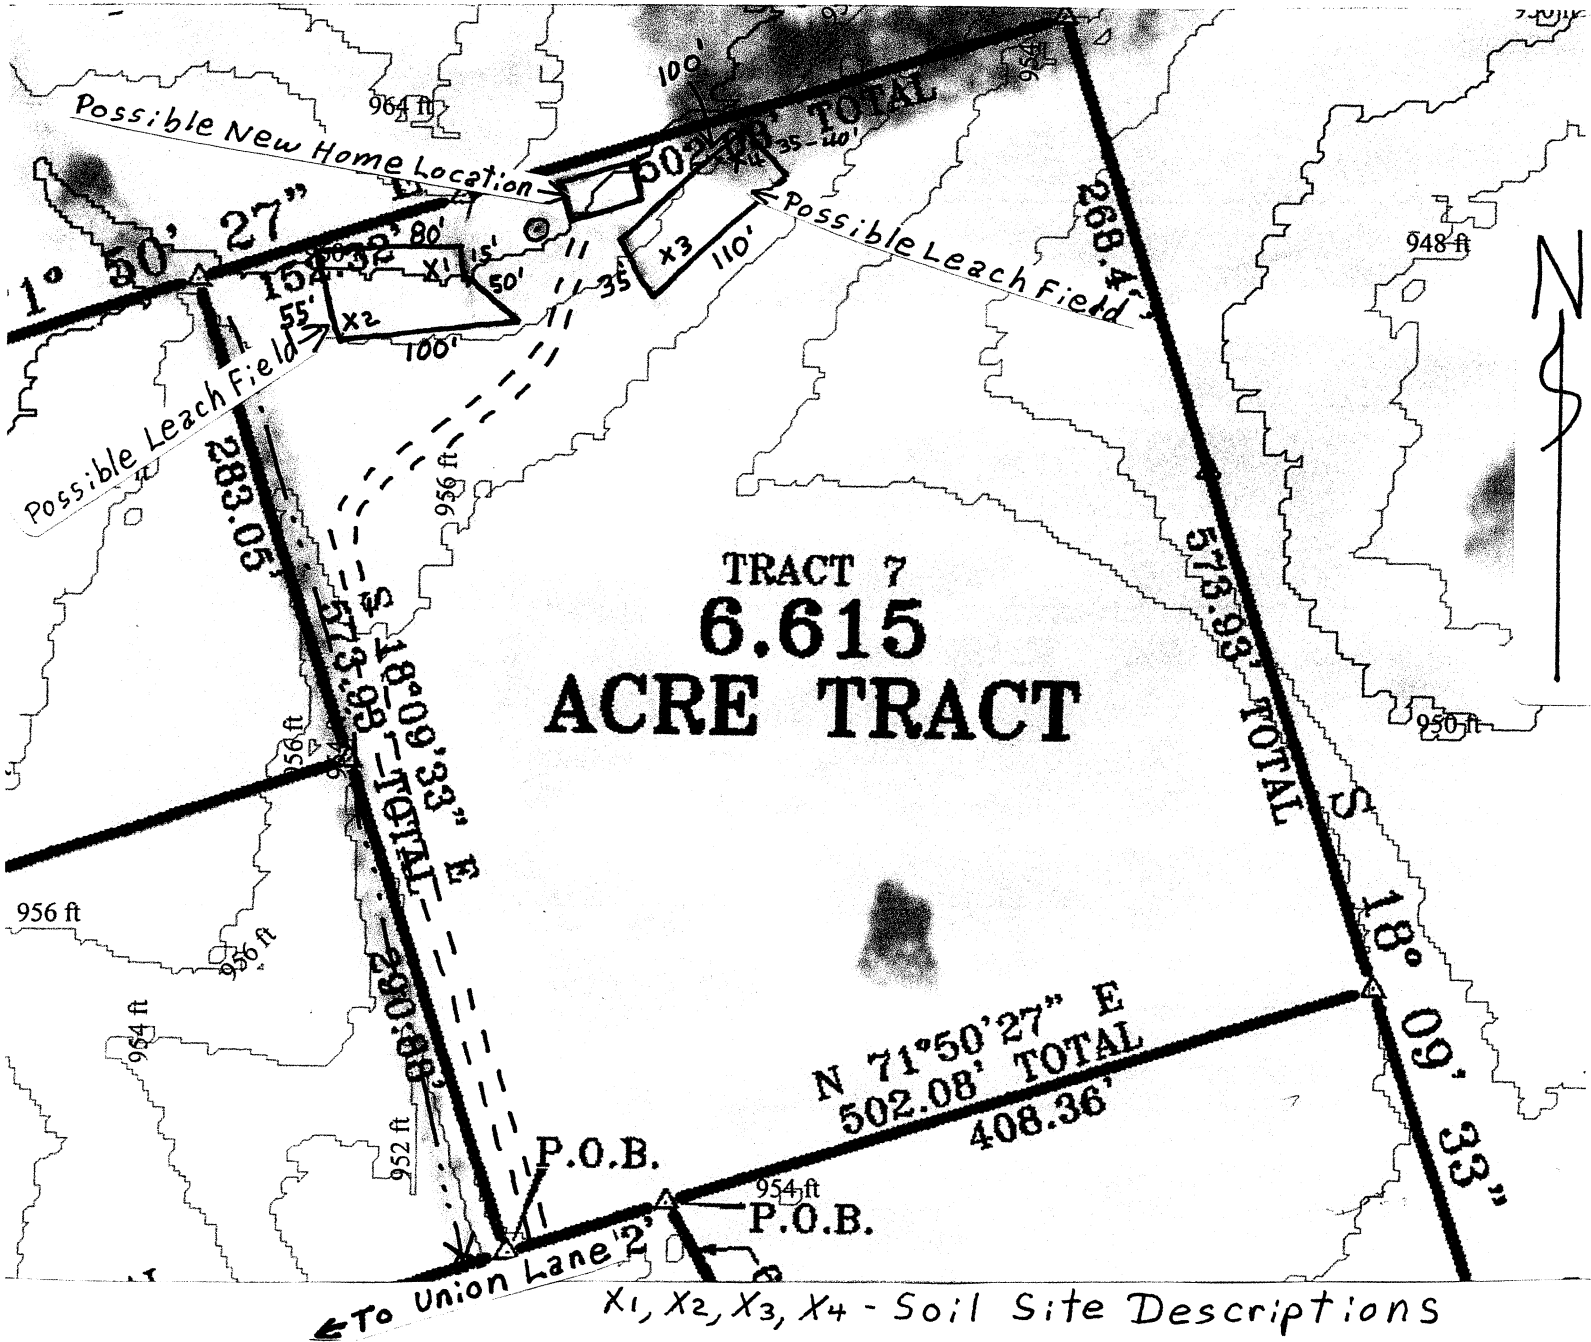
The upper part of the proposed leach field areas are more loamy and better drained. As you travel downslope the soils have more clay on the flatter slopes and the depth to a seasonal high water table is shallower as shown by the soil site descriptions. The #3 & #4 soil site description area seems to be a little better area for a leach field as shown by the soil site descriptions. However these soils are all very similar on this out-slope glacial fan area. The highest part of this landscape should be used for this STS leach field for the best infiltration of the waste water. The natural intermittent drainageway on the western side of the property should be kept open and maybe cleaned out and revegetated with a permanent grass cover. The intermittent drainageway can also serve as an outlet for any subsurface French drains on the lower side of the leach field, or along the driveway, if ever needed. These proposed filter field areas are large and can serve as the primary and secondary leach field areas.

We have shown the location of the proposed STS leach fields on the sketch map. We have marked the proposed filter field areas with pink wire flags along the boundary and/or on the boundary corners. The soil description sites are marked with orange wire flags and the number of the description is marked on the flag. The approximate dominion, of the proposed filter field areas, are marked on the sketch map. The proposed leach field area is just an indication of the area that can be used, the installer or the health department will determine where the filter lines will be located. The filter field lines would need to be located level on the contour around the slope. These soil descriptions were taken at random to show the soil properties at different areas within the proposed filter field area and the sketch map is not to scale. The proposed leach field can be extended around the slope, if needed, as long as you stay on the property. We gave a general house site location (example that may change) on the sketch map to give you a possible reference point, for this report.
