Sketch Map for Countrytyme Property

Union Pastures-Track #7 Ross County

Soil and Site Evaluation Discussion

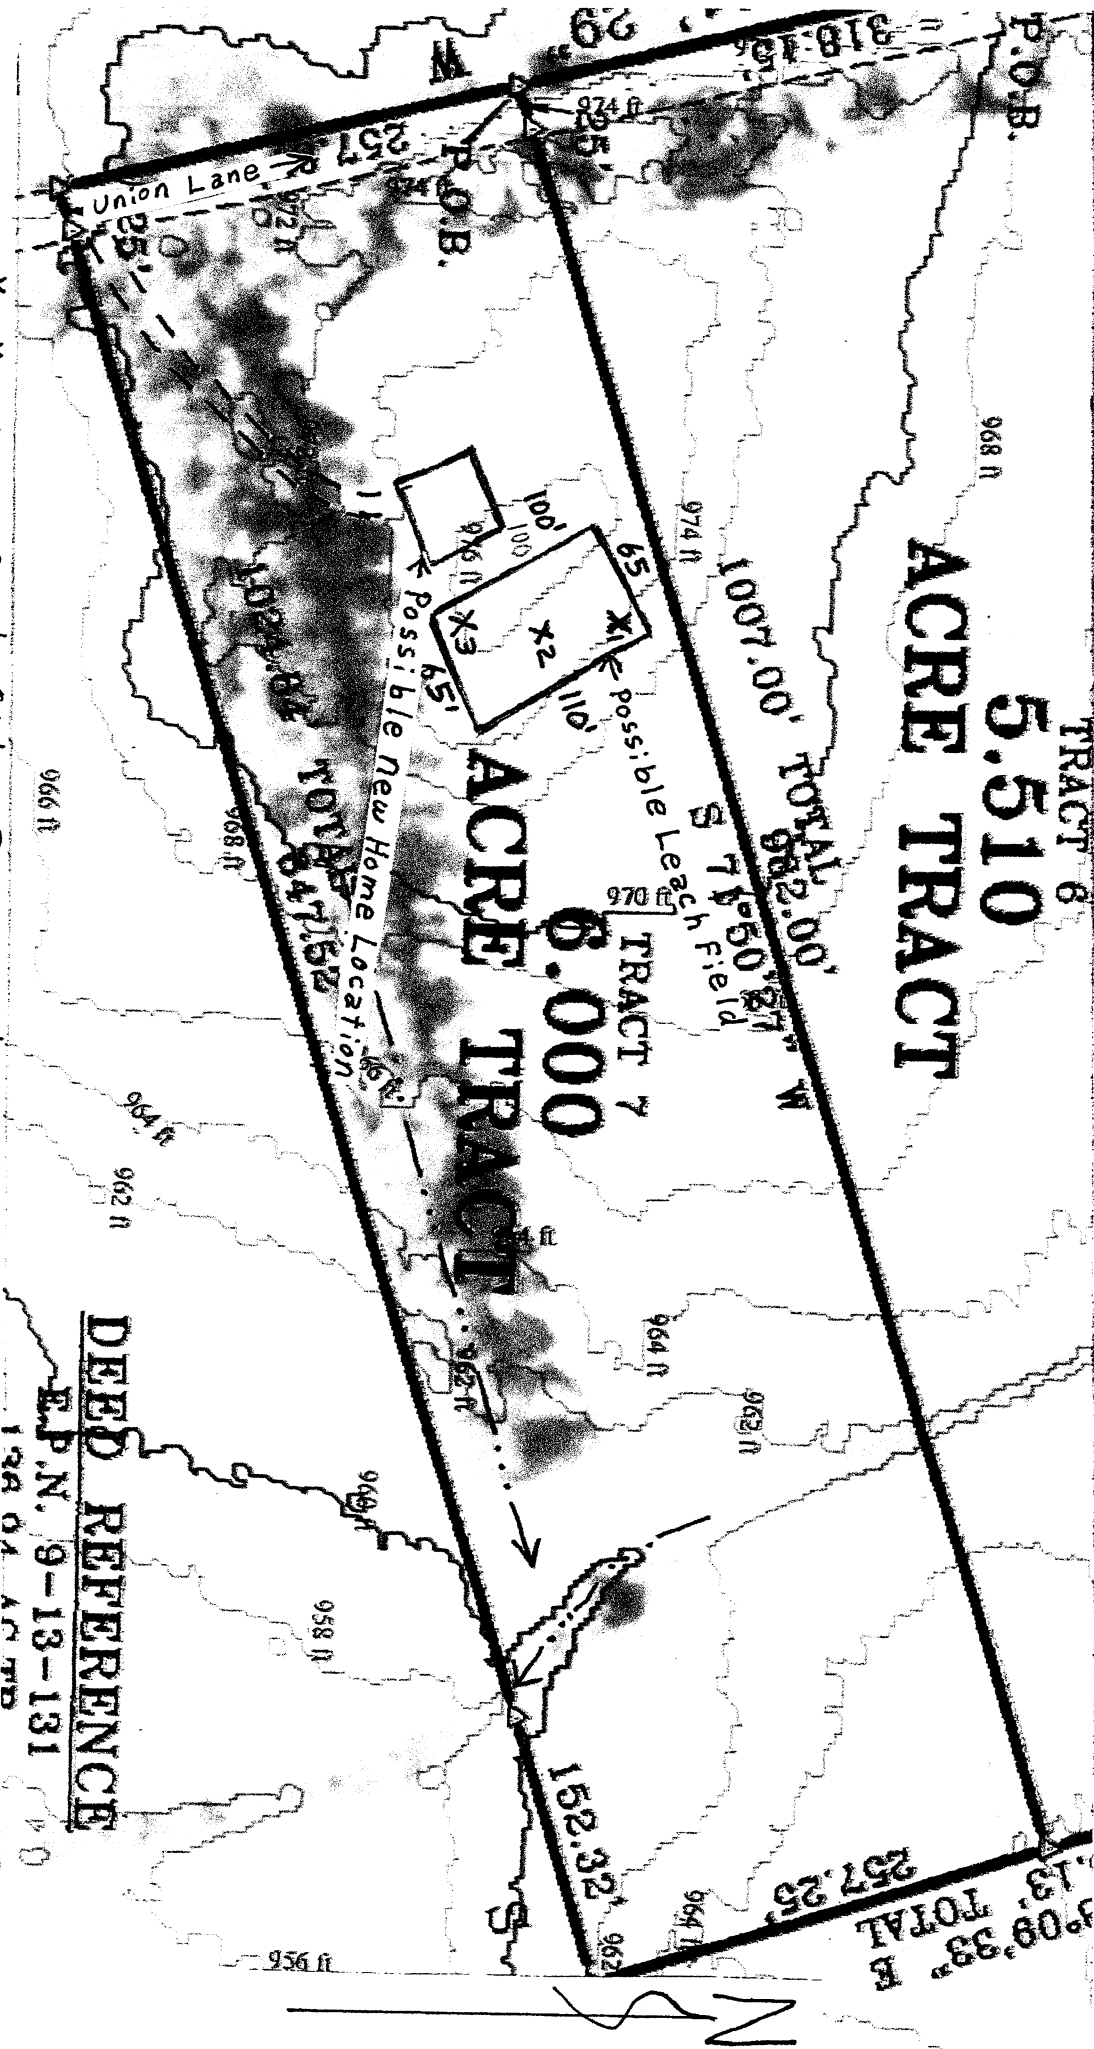
X1, X2, X3 - Soil Site Descriptions

=== Possible Driveway Location

→ Slight swale in Landscape for surface water flow + Direction

These are all Approximate Locations (not to scale)

We have shown the location of the proposed STS leach field on the sketch map. We have located a possible new home location. We have marked the proposed filter field area with pink wire flags on the boundary corners. The soil description sites are marked with orange wire flags and the number of the description is marked on the flag. The approximate dominion, of the proposed filter field area, is marked on the sketch map. The proposed filter field area is just an indication of the area that can be used, the installer or the health department will determine where the filter lines will be located. The filter field lines would need to be located level on the contour around the slight to gentle slope. These soil descriptions were taken at random to show the soil properties at different areas within the proposed leach field area and the sketch map is not to scale. We gave a house site location (example that may change with new owner) on the sketch map to give you a possible reference point, for this report.
