Sketch Map for Countrytyme Property

Perry County, Ohio Township Road 324 – Lot #1

② we used the 12-24" Depth For H. Linear Loading Rate used 710 % slope site and Soil Evaluation for Sewage Treatment and Dispersal

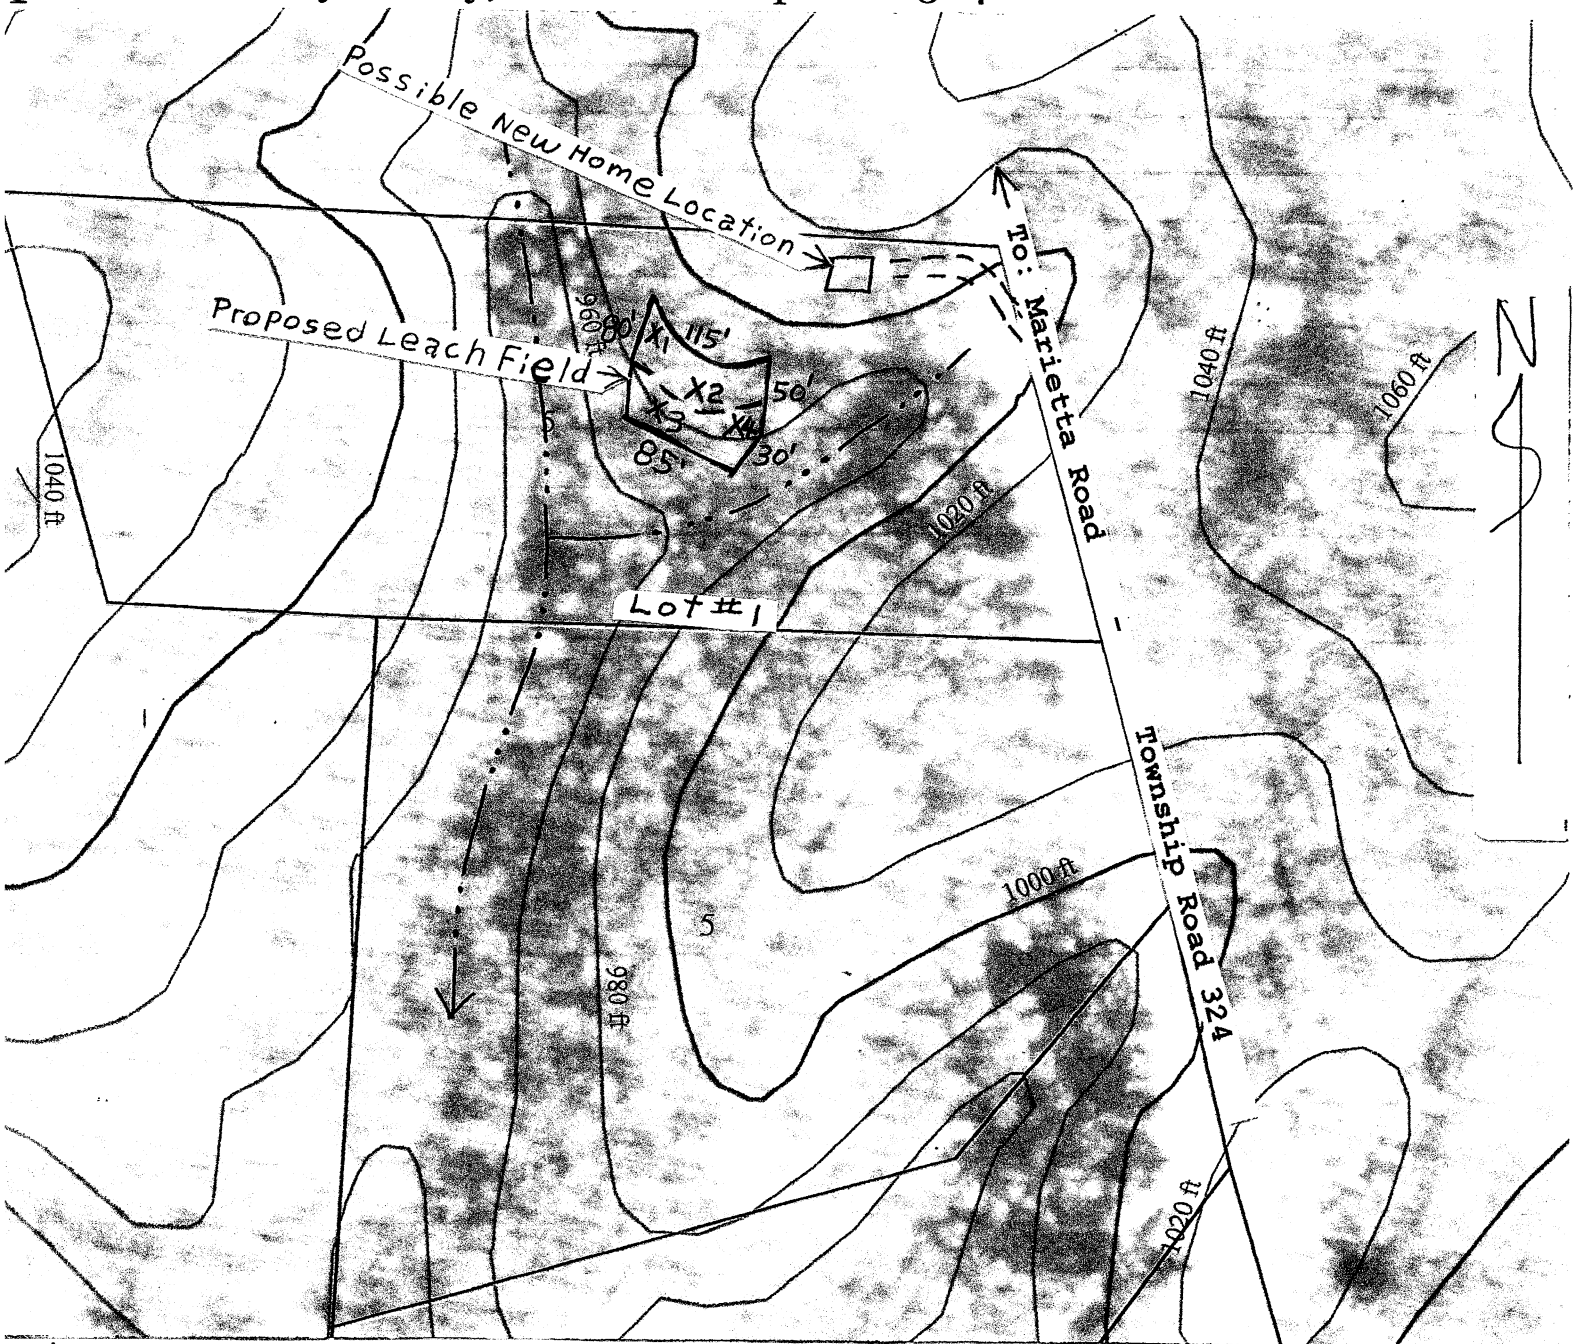
X₁, X₂, X₃ - Soil Site Descriptions

==== Approximate Driveway Location

←...— Intermittent Drainage way

These Are all Approximate Locations (not to scale)
