COUNTRYTIME  
C/O JEFFREY LONGHENRY  
0 FLINT RIDGE RD.,  
NEWARK, OHIO 43055

PARCEL: 033-103422-00.008

Lot 7

Site and Soil Evaluation for Sewage Treatment and Dispersal

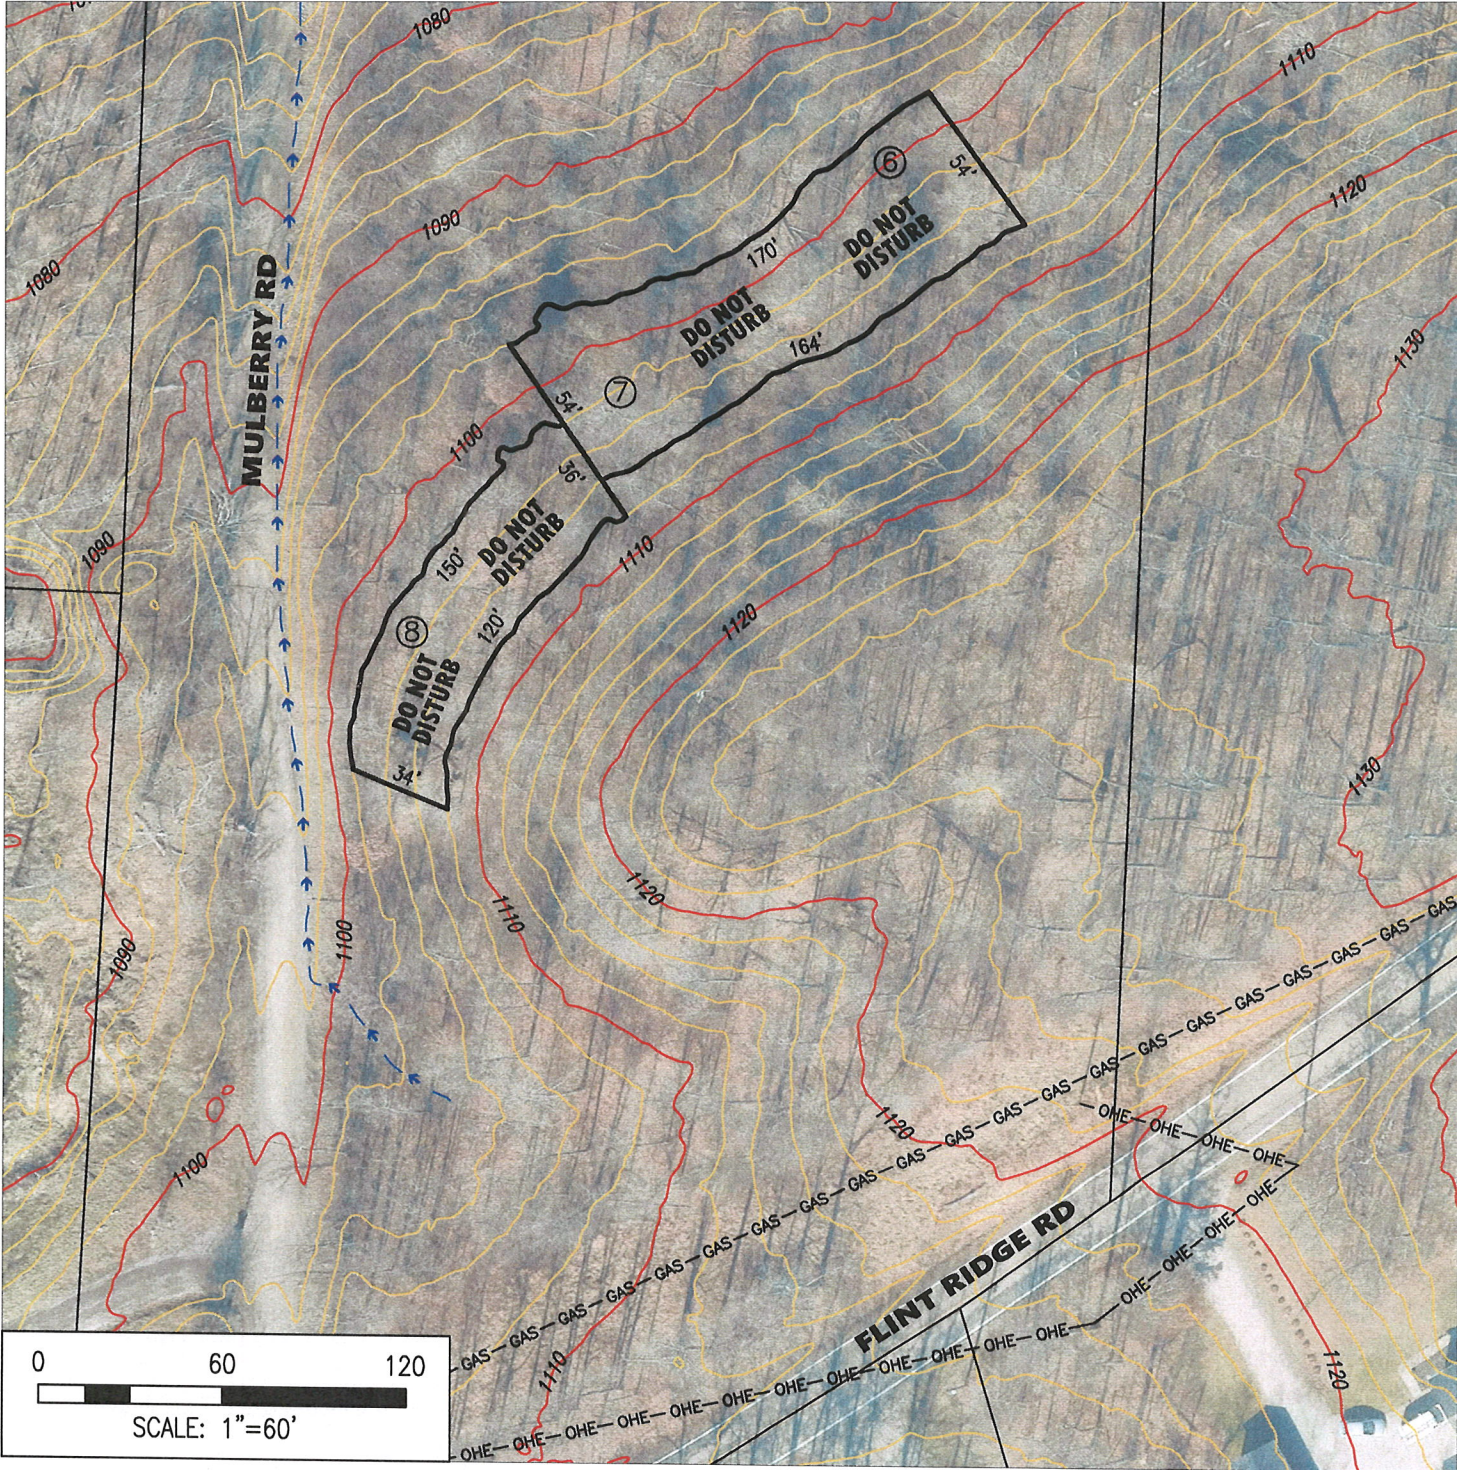
NOTE: SITE PLAN PREPARED USING GARMIN GPS, LICKING CO., AND OGRIP GIS DATA. DATA SHOWN IS ASSUMED CORRECT, BUT HAS NOT BEEN SURVEYED. HOUSE, WELL, BURIED UTILITIES AND DRIVEWAY LOCATIONS, IF SHOWN, ARE NOT FINAL. ALL SHOULD BE SITUATED ON THE LOT TO ALLOW FOR AN ON LOT SYSTEM THAT MEETS, OR EXCEEDS, THE MINIMUM SIZE REQUIRED.

NOTE: DO NOT DISTURB DESIGNATED LEACH FIELD AREAS UNTIL INSTALLATION

2' CONTOUR INTERVAL

SCALE: 1"=60'
