This plat is based on an actual field survey performed by or under the direct supervision of Jeremy Hart Wallingford, Registered Land Surveyor 8539 on September 1, 2023.

**Countrytyme Land Specialist, LTD**  
 Orange Township – Meigs County – Ohio  
 Part of the N.E. 1/4 & S.E. 1/4 of  
 Section 18, Township 4 North, Range 12 West  
 O.R. Vol. 406 Pg. 1147  
 Orig. 25.465 Ac.  
 A.P.N. 1000083001  
 Scale: 1" = 200'  
 September 1, 2023

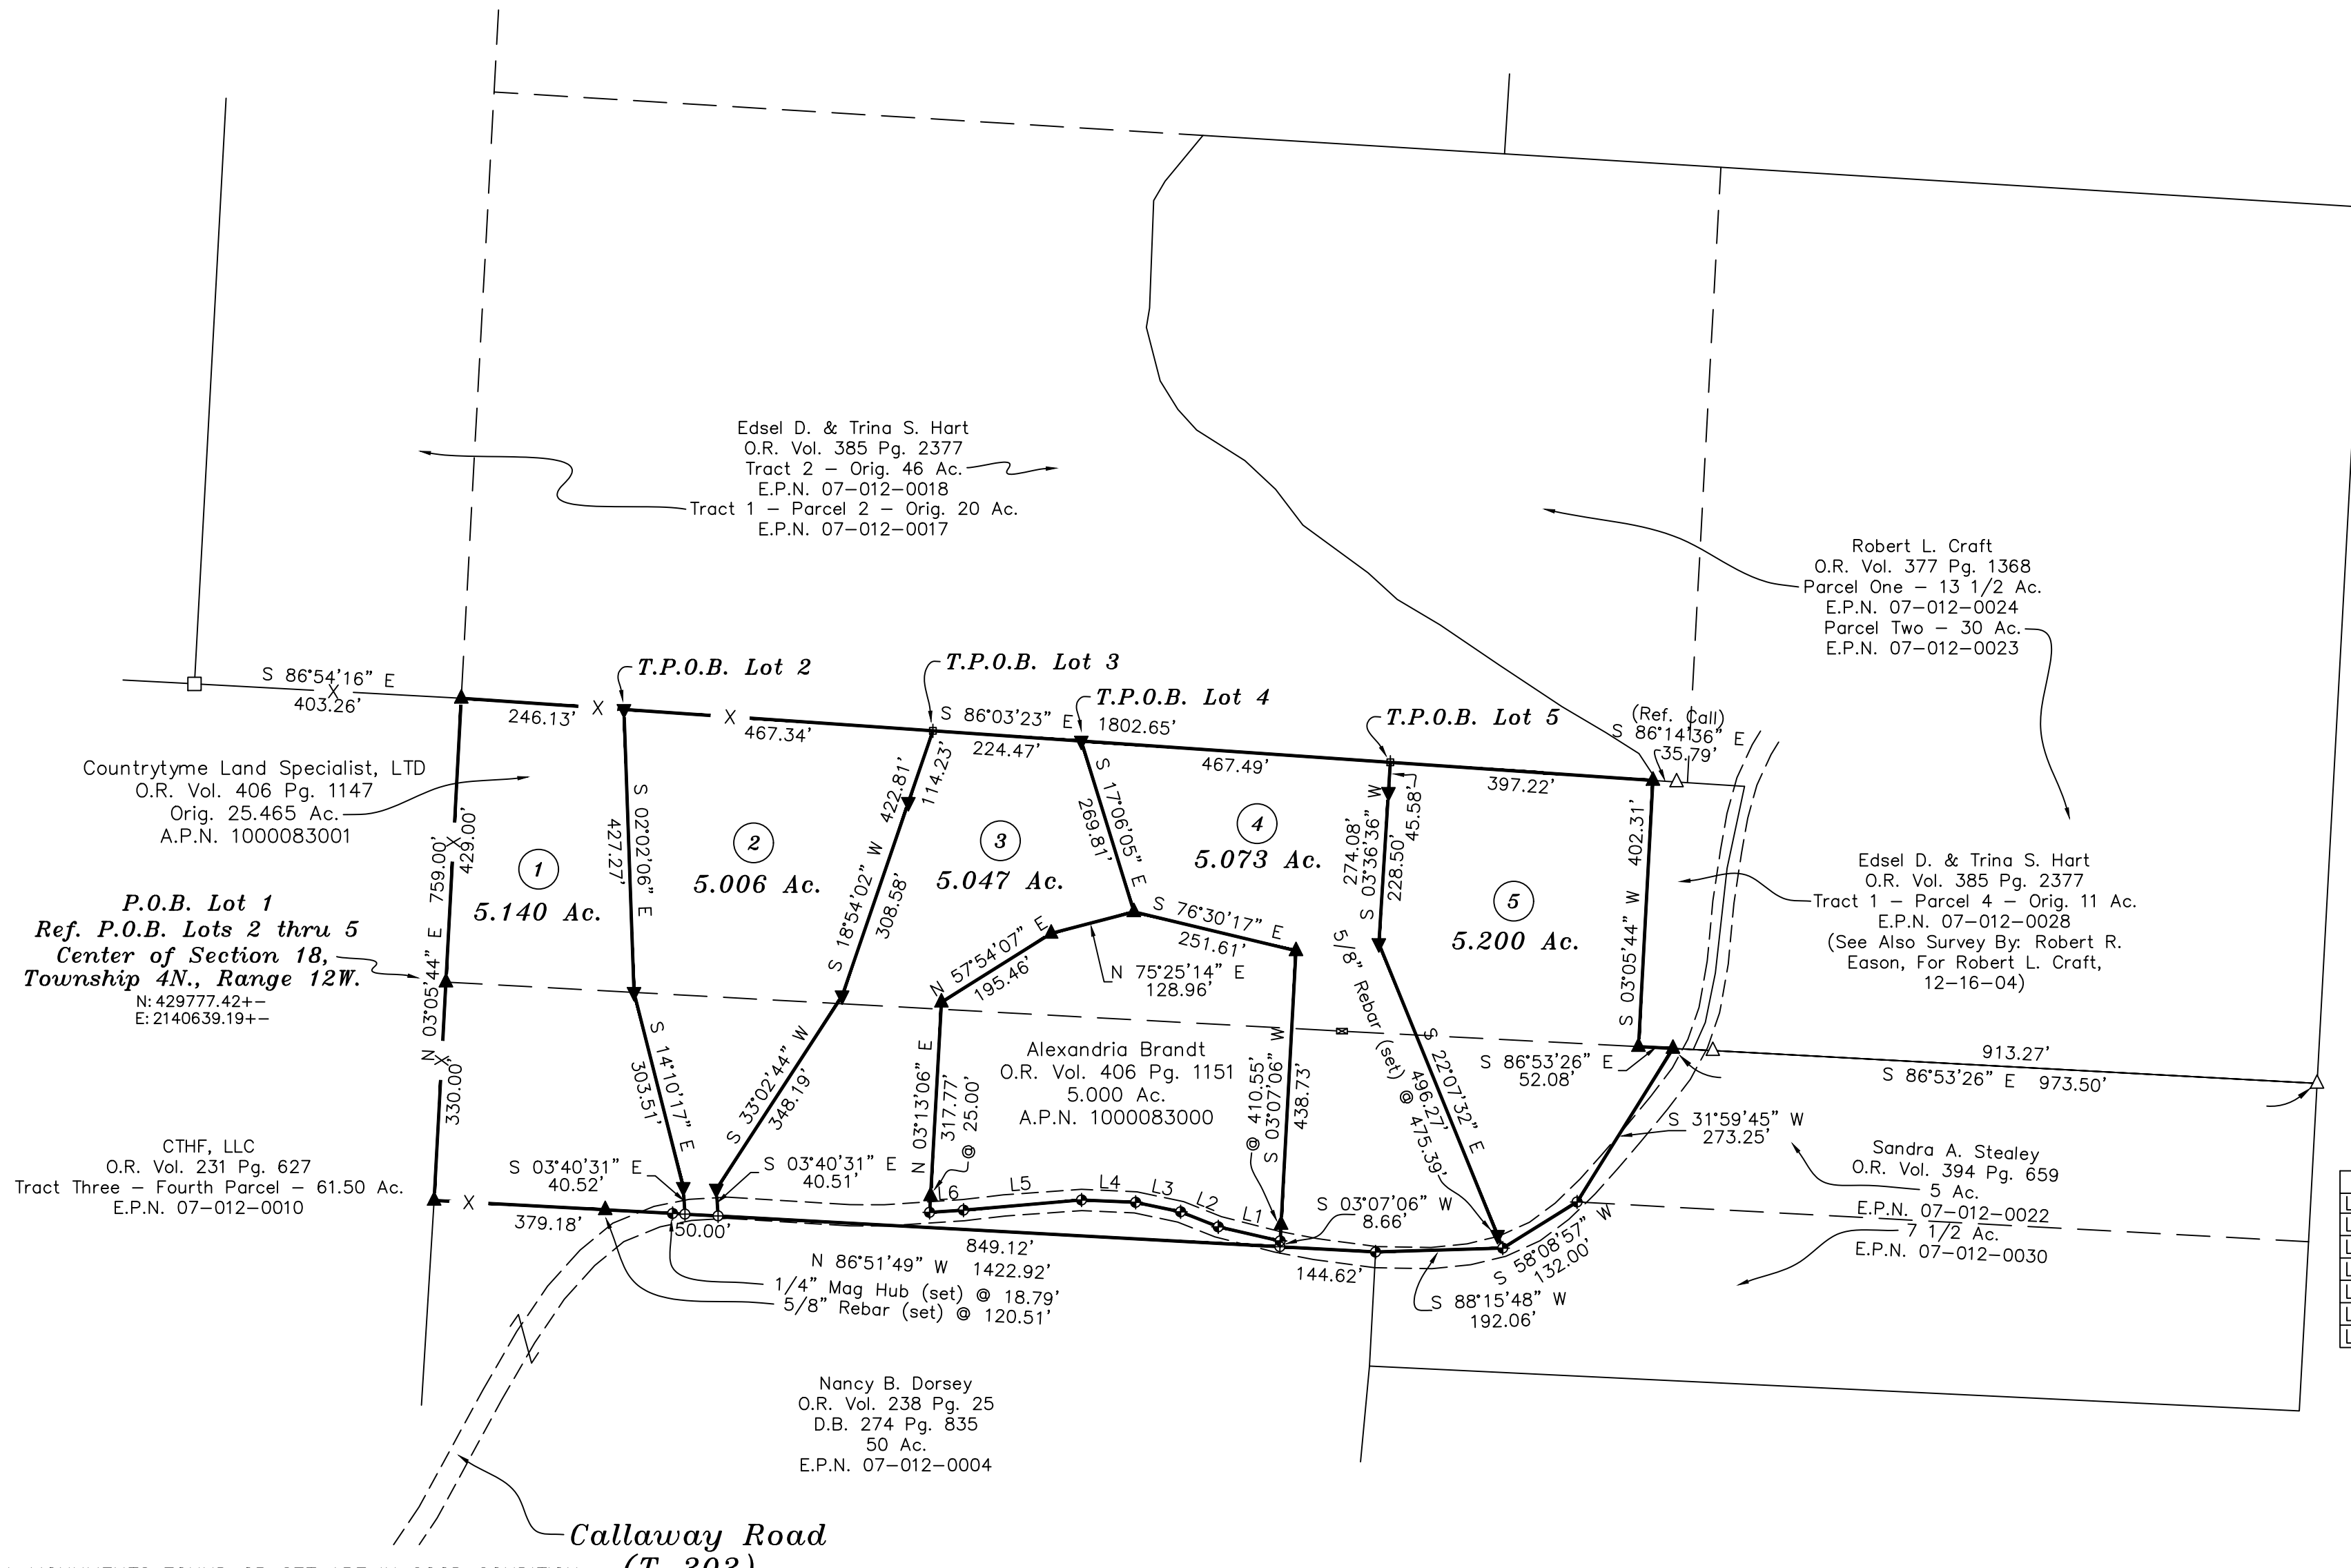
Bearings are based on the grid bearing N 03°05'44" E, Ohio State Plane Coordinate System, Ohio South Zone, North American Datum 1983.

Line Table		
LINE	BEARING	DISTANCE
L1	N 77°03'56" W	95.92'
L2	N 68°18'52" W	61.00'
L3	N 78°07'14" W	69.45'
L4	N 87°26'36" W	81.65'
L5	S 85°04'03" W	178.83'
L6	S 86°13'15" W	51.27'

ALL MONUMENTS FOUND OR SET ARE IN GOOD CONDITION.

NO EVIDENCE OF OCCUPATION EXISTS ALONG PROPERTY LINES INDICATED BY SOLID LINES.
